A Report on Structural Roof Framing at The McCelvey Center

York, South Carolina

Submitted to:
Culture & Heritage Museums

Thursday, May 12, 2022

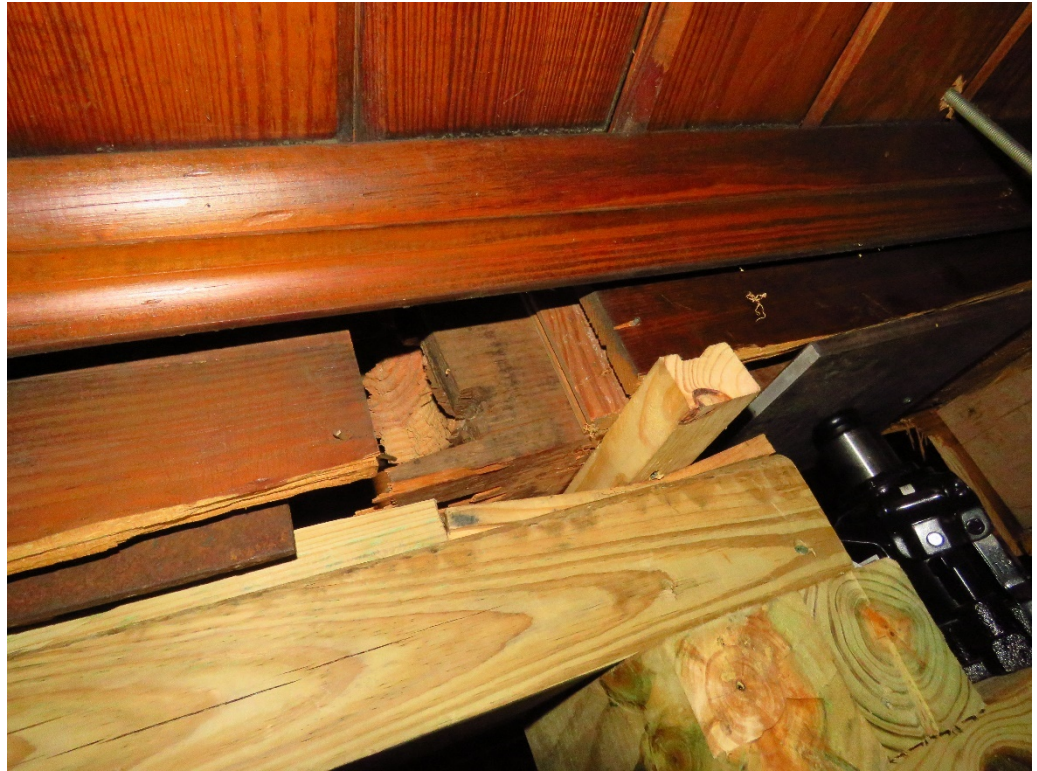
There is a break in the truss east of the center shoring tower, near the end of a steel plate that joins the two truss pieces at or near the center. The plate could not be seen for its full length, but it appeared to be approximately 4 to 5 feet long. BPE could not determine whether or not the connection plate was centered on the joint. See Figures 1 through 3.

Figure 1: View of break in Truss 1 from below

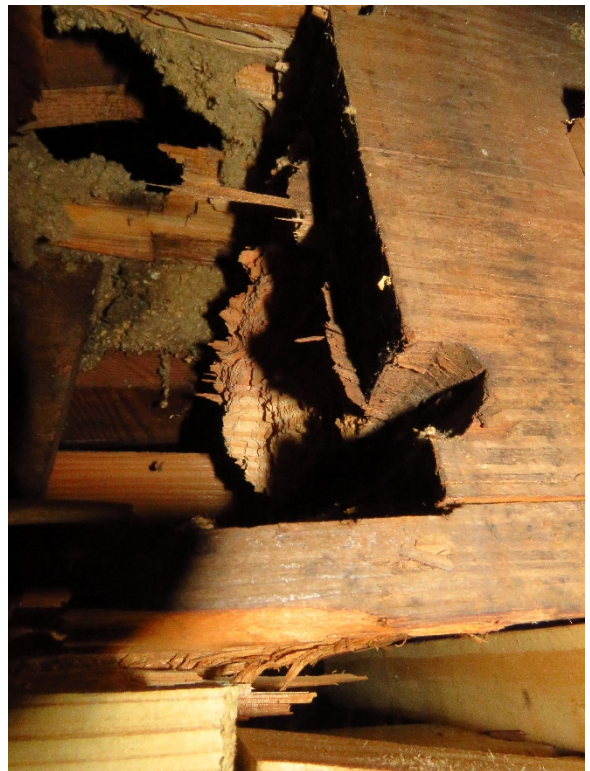
Figure 2: View of break in Truss 1 from below

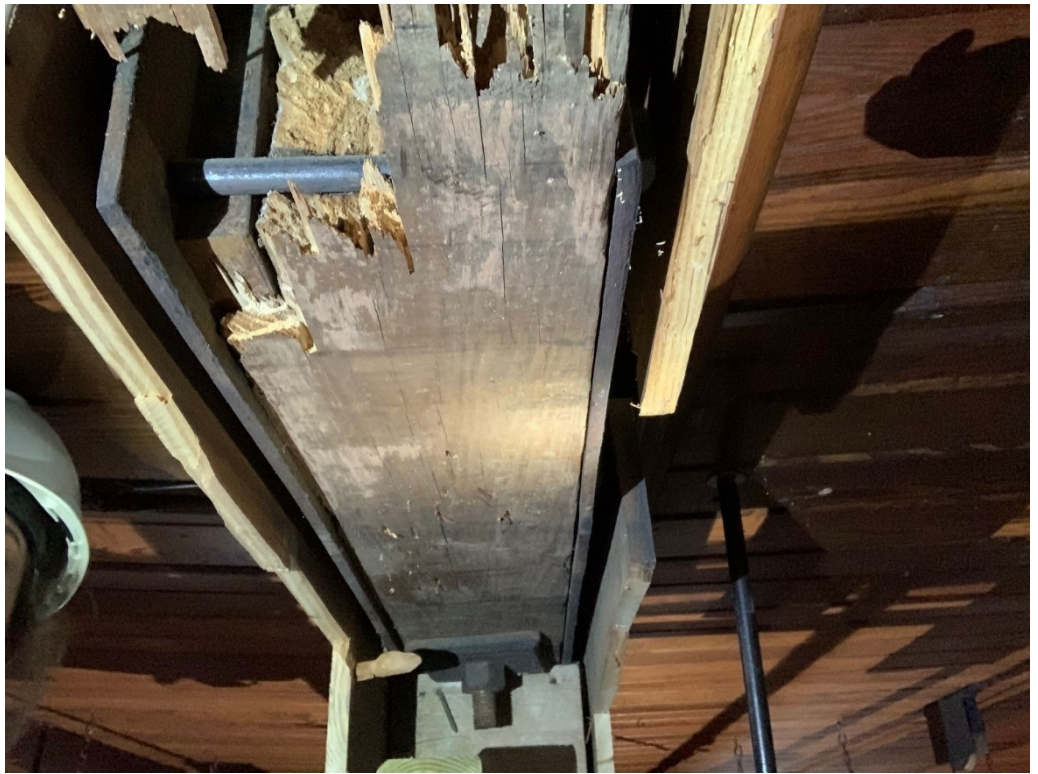
The break in the truss was, not unexpectedly, at a bolt. It appears that the bolt, with a diameter of approximately 3/4 of an inch, was a horizontal bolt near the bottom of the bottom cord, approximately an inch above the bottom edge of the bottom cord. It appears to have been a smooth bolt rather than a threaded rod. See Figure 3.

Figure 3: View of break in Truss 1 from below

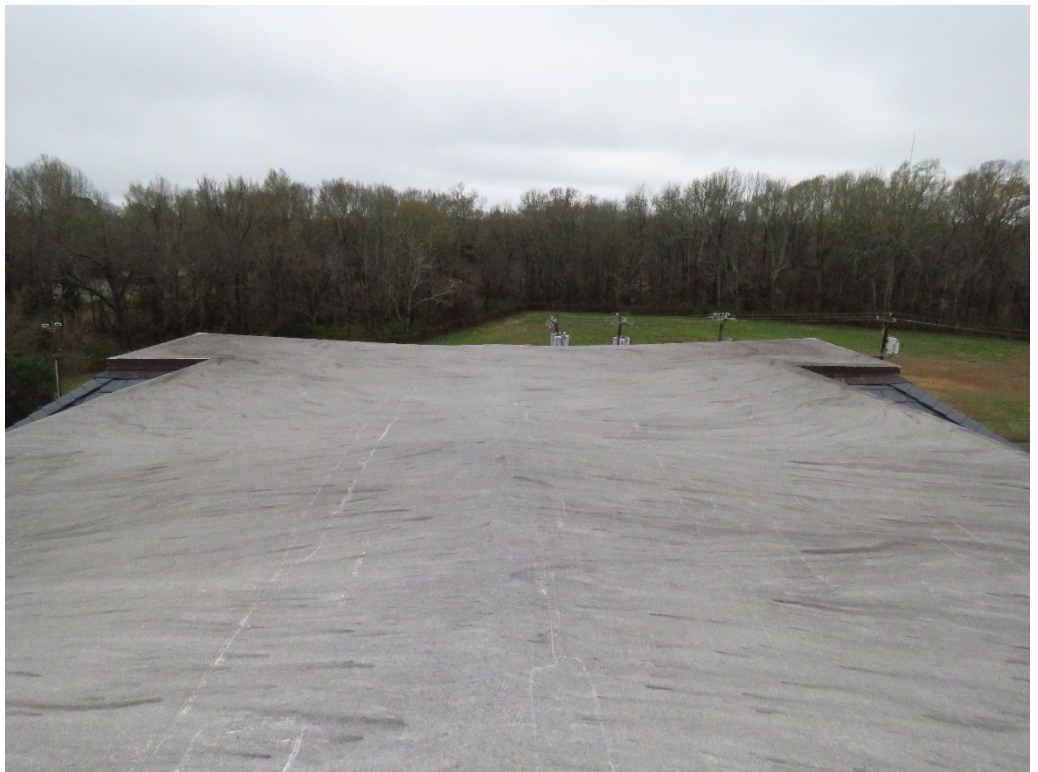
Sara Johnson, of the Culture & Heritage Museums, informed BPE that the chord might have been broken for over a decade, since some roof sagging was reported during a past construction roofing project, approximately 10 to 15 years ago. See Figure 4 for a recent view of the roof sag. BPE suspects that the break in the truss was far more recent than that, because there would have been significant deflection in the truss before it broke, enough to be of concern to a roofer. BPE further thinks that the debris found on the stage, just before the local engineer was first called in, likely fell when the truss bottom chord broke.

Figure 4: Condition of roof sag in March 2022

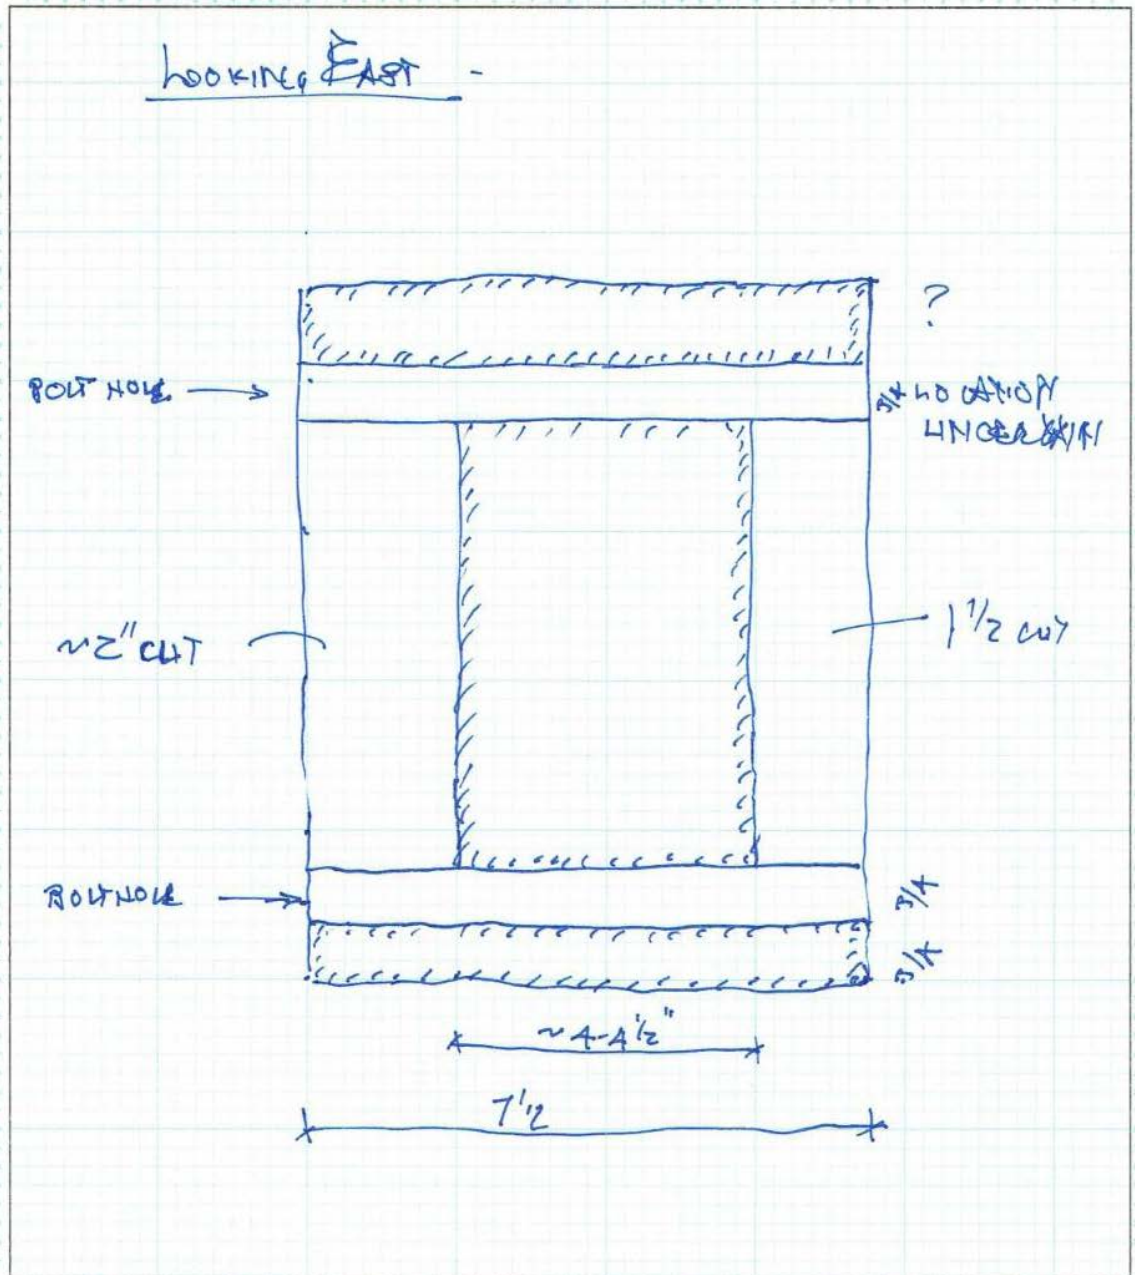
The bottom cord was notched at a few locations on each side of its center. It appears these notches were created to attach a steel plate with bolts to connect the bottom chord splice in the center of the truss. The remaining wood appears to be roughly 7 1/2 inches wide minus a 1 1/2 inches to 2 inches on each side leaving a width of roughly 4 to 4 1/2 inch. See field sketch in Figure 5. It is clear that the truss has failed here.

Figure 5: Truss 1 cross section field sketch

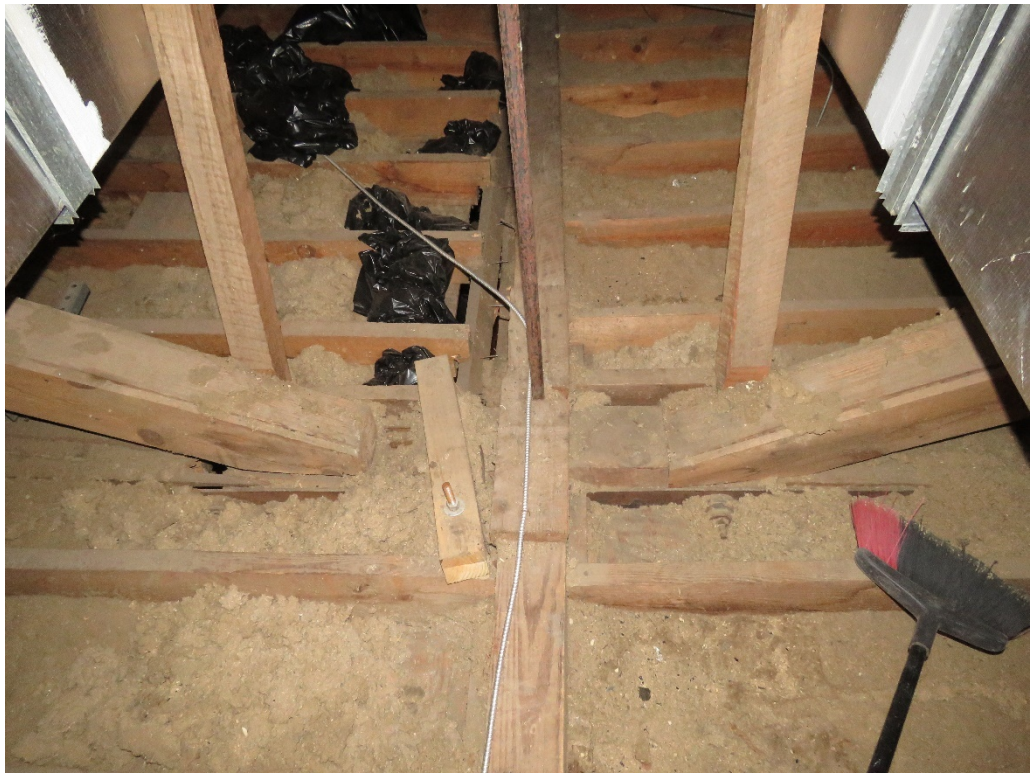
The bottom chord of Truss 1 seems to be cut the same way as Truss 4, however, instead of a wooden side piece, the side pieces are made up of thin metal plates along each side with thicker plates in the notches. See Figure 6. See Figure 22 for sketch of Truss 4's wooden side pieces.

Figure 6: Metal plate side pieces at Truss 1 bottom chord

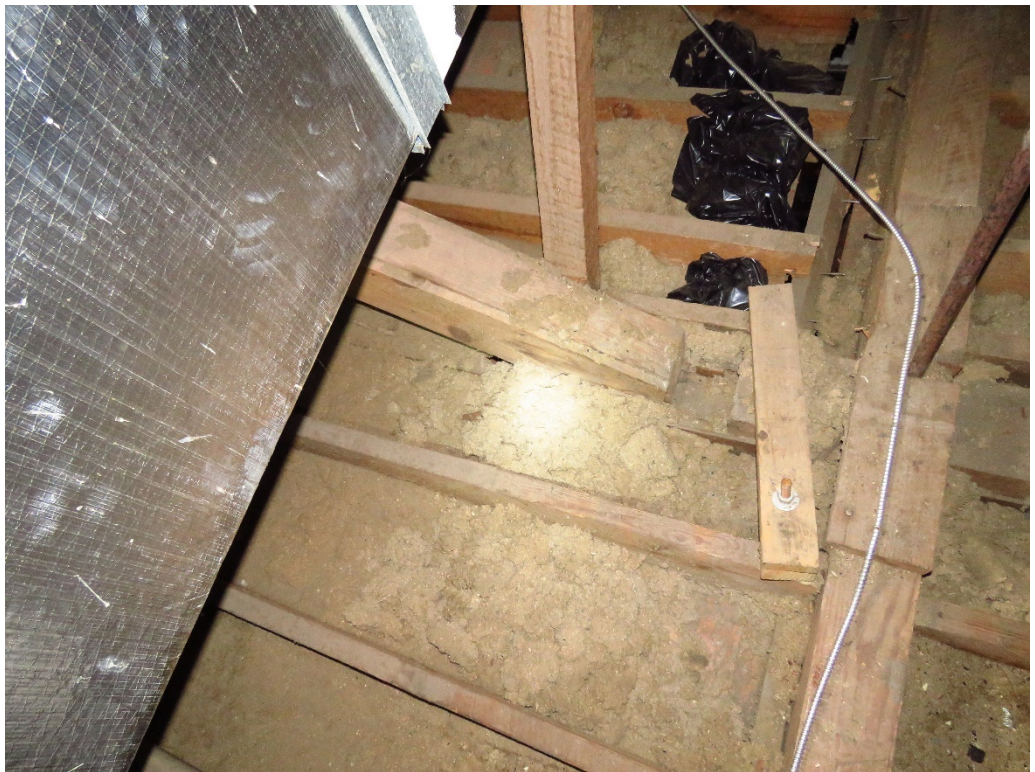
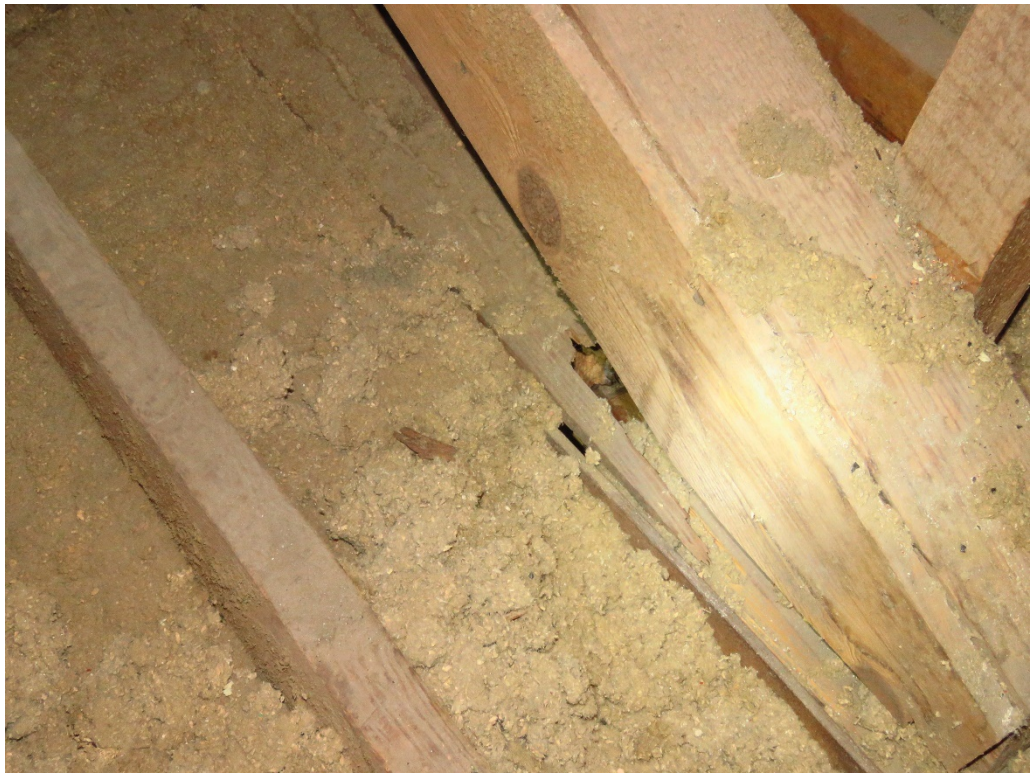
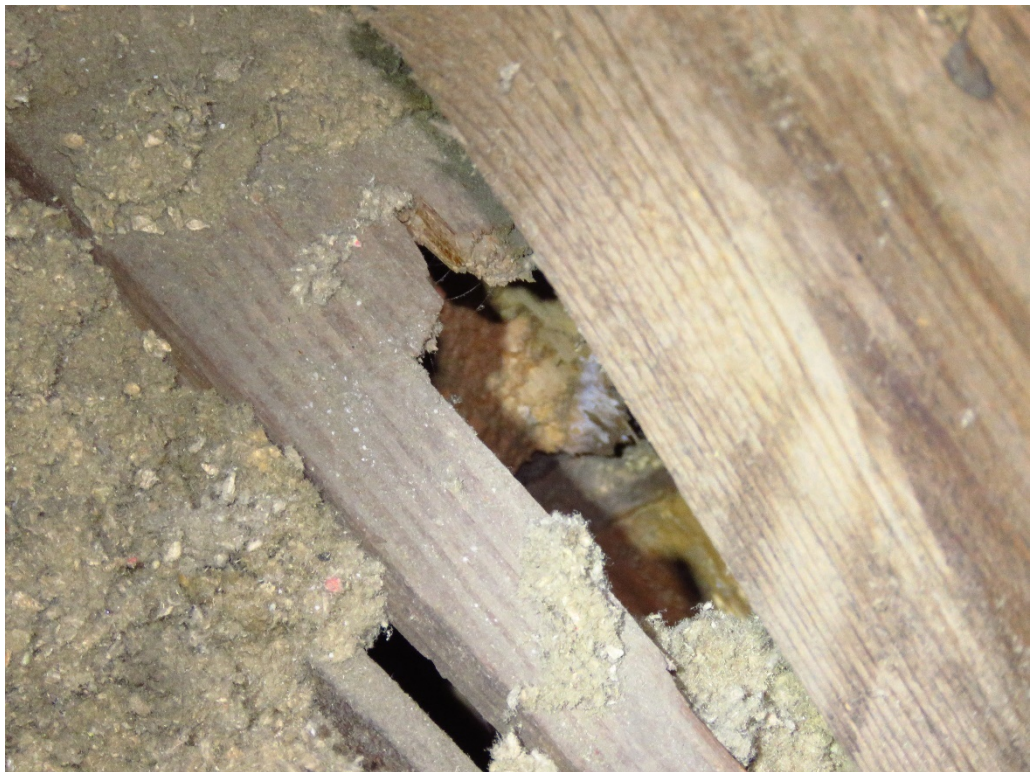
The break in the truss east of the center rod can also be seen from above in the attic. See Figures 7 through 9.

Figure 7: View of break in Truss1 from above

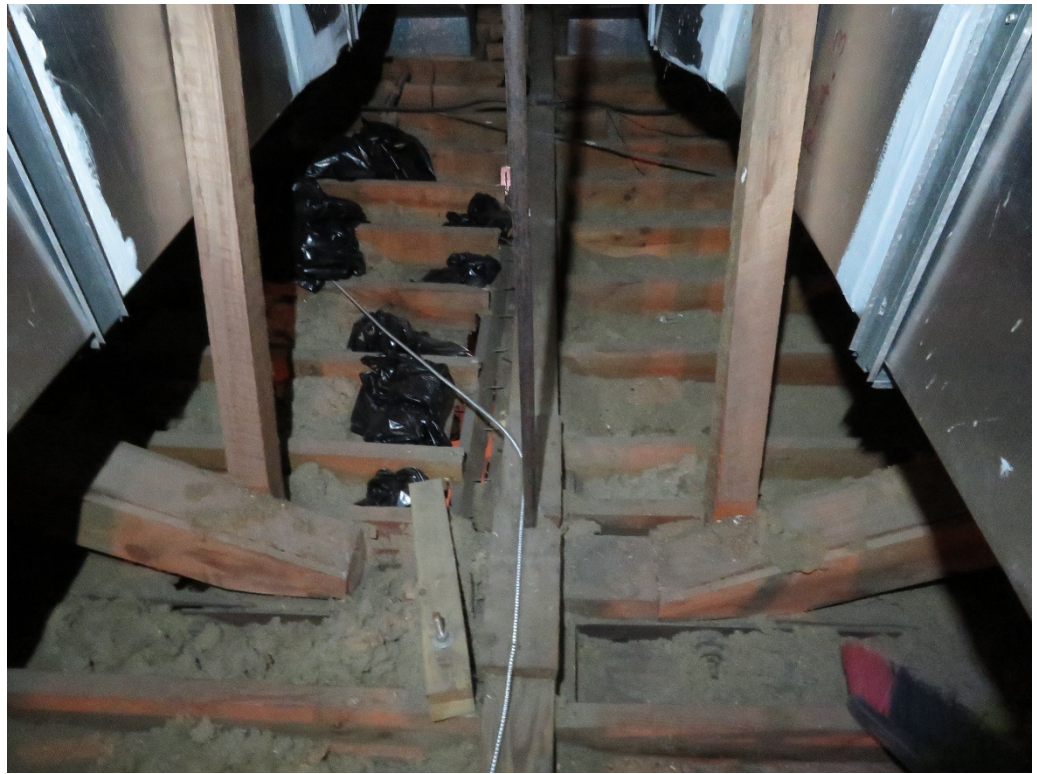
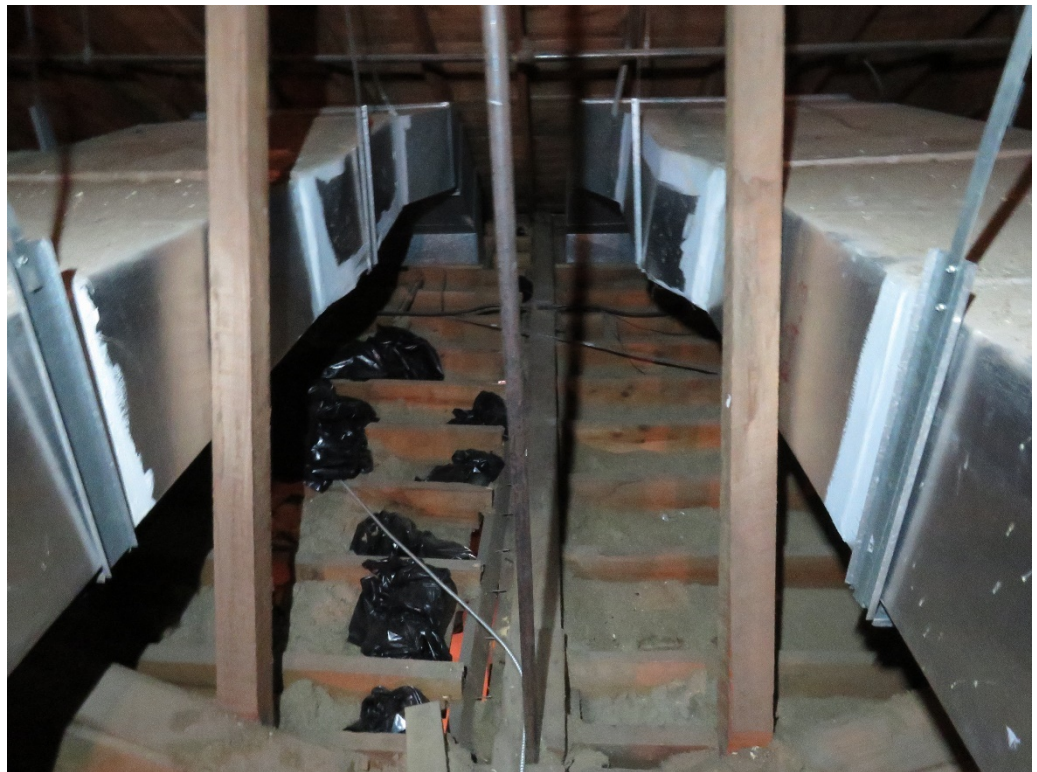
Running from the middle of the truss going south to the south wall, is a girder. This girder is supported at the middle panel point of the truss. On each side of this girder are small ledgers which support joists running east-west in the attic, which in turn support the beadboard ceiling over the stage. See Figures 10 and 11. As the girder dropped with the truss bottom chord, the ledger on the east side of the girder was pulled away from the girder by the joists which are attached to it. See Figures 12 through 15. As the bottom chord of the truss broke, the joists running parallel to the truss and bearing on the girder moved away from the girder, pulling the ceiling boards open and allowing debris to fall onto the stage below. Some of the ceiling boards south of the truss have separated from one another approximately 6 1/2 inches. See Figures 16 and 17. ***Note that access in the attic in this area is extremely dangerous.***

Figure 10: Girder running from Truss 1 to south wall

- Additionally shore the east and west ends of the stage truss (Truss 1).
- Shore the north-south girder currenting tying into the center of the stage truss (Truss 1).

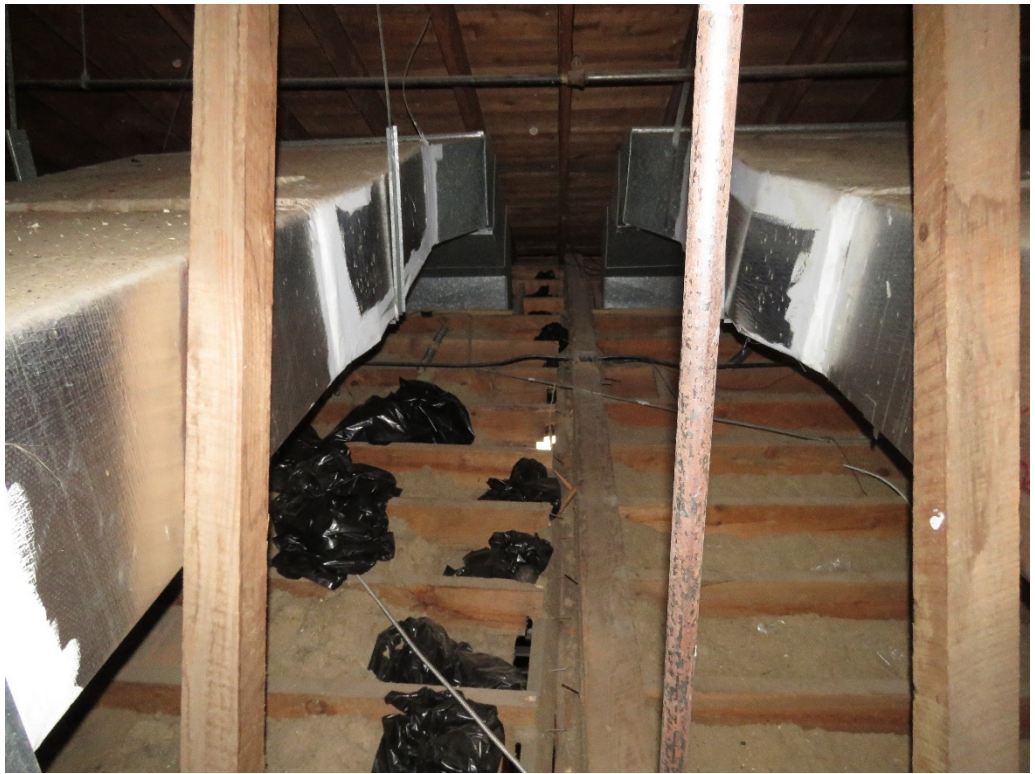
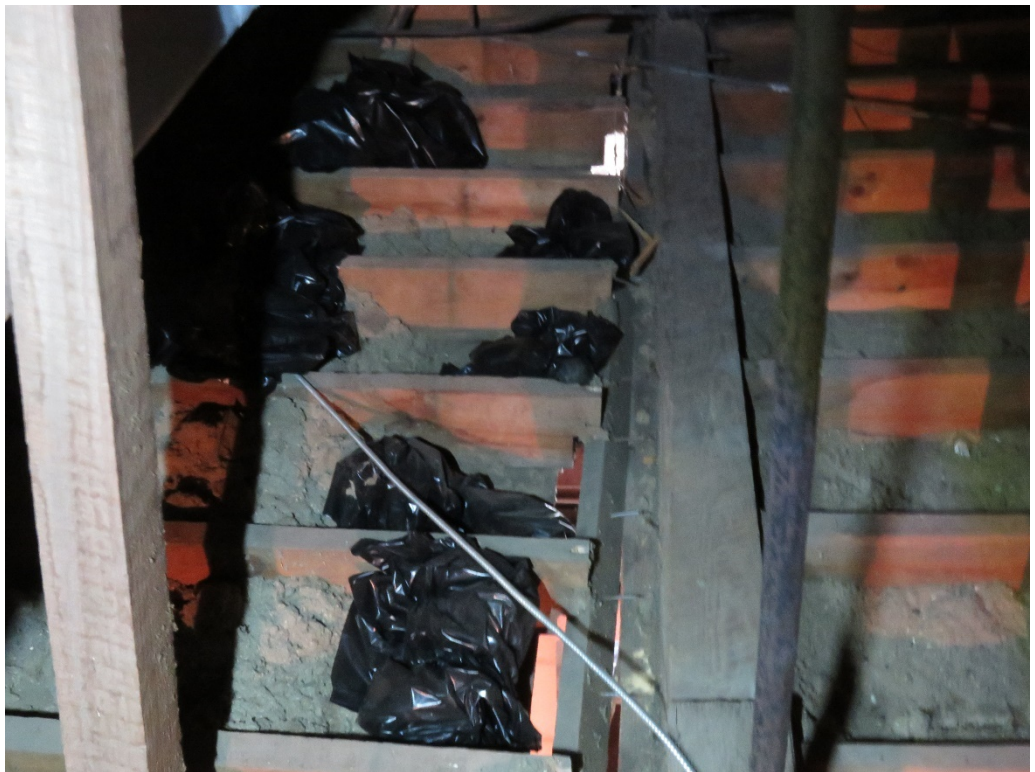
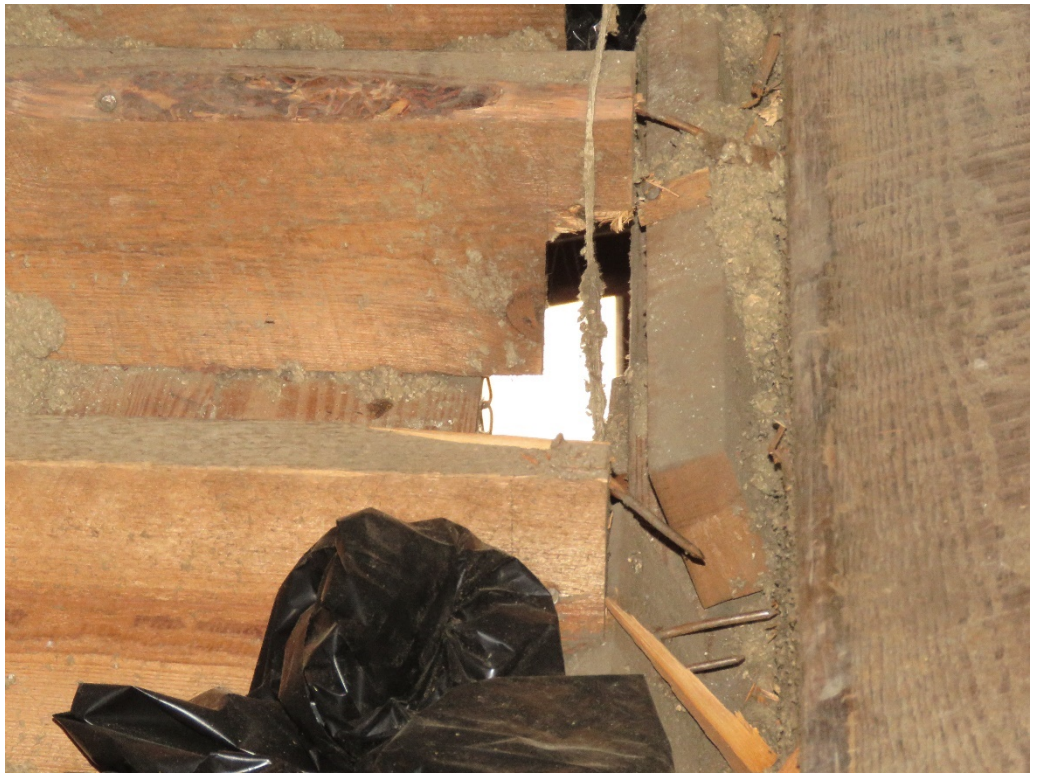
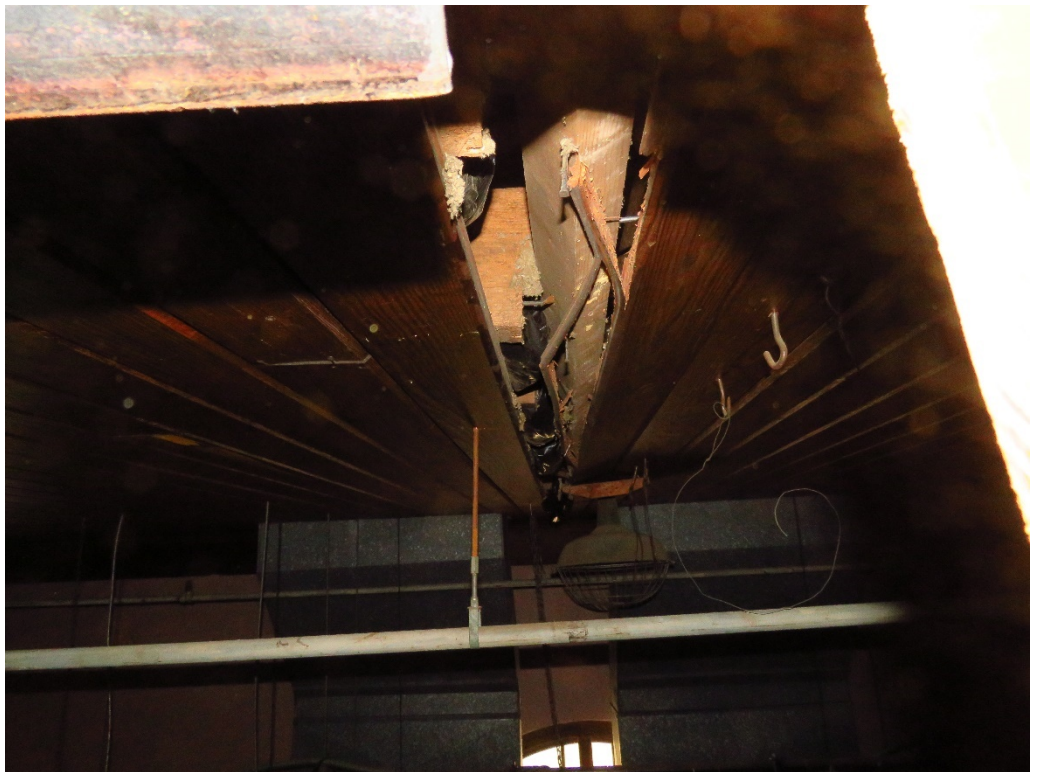
Figure 12: Ledger pulling away from north-south girder

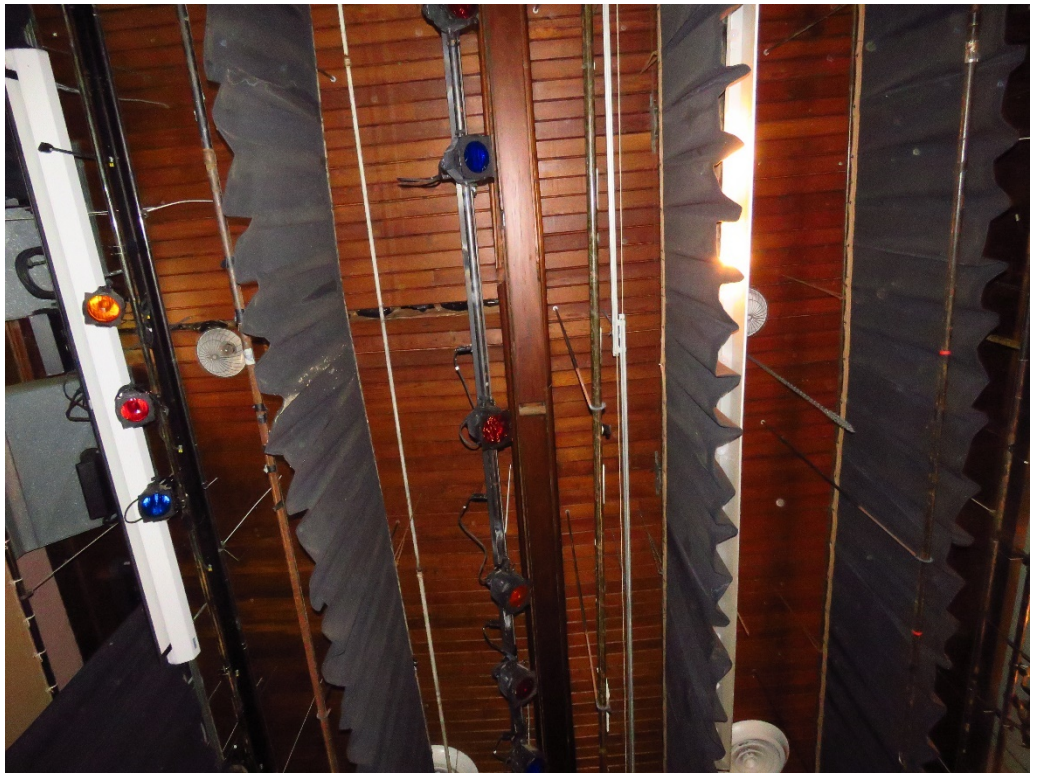
Figure 16: Open ceiling boards south of Truss 1

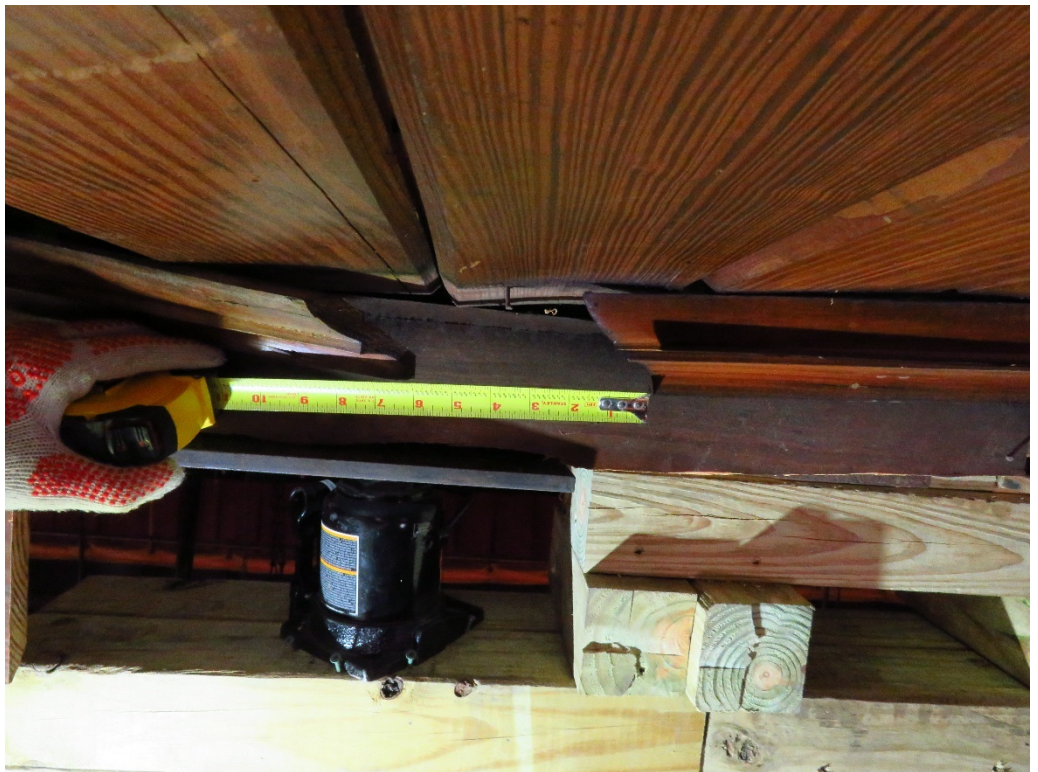
Figure 17: Open ceiling boards at Truss 1

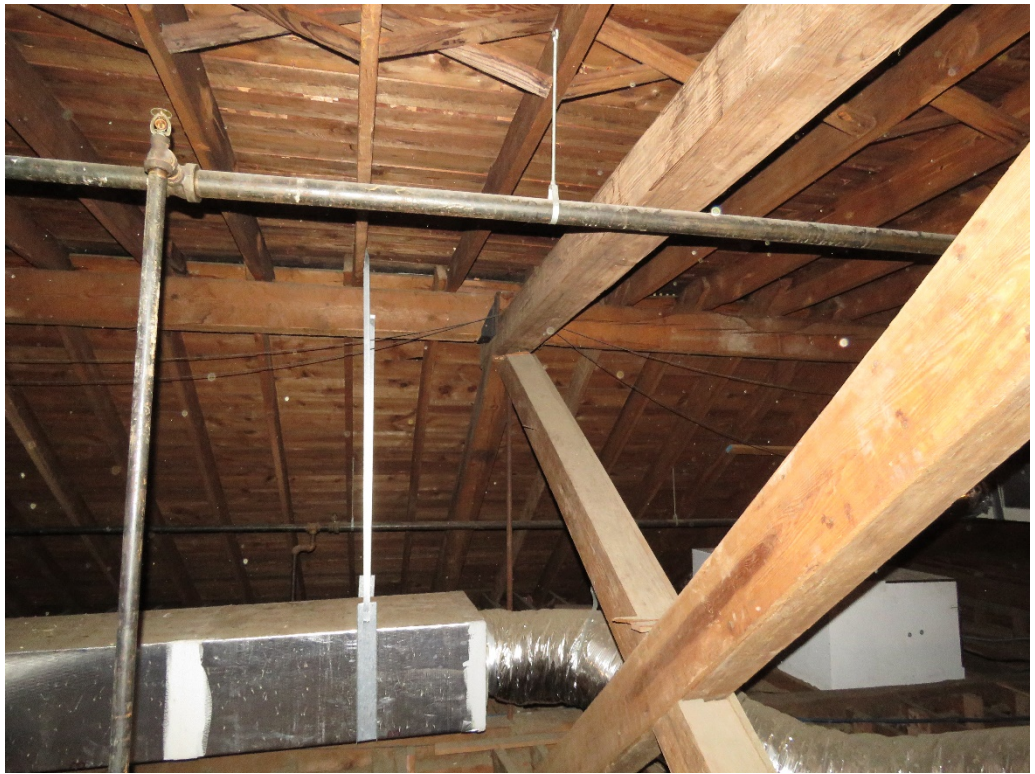
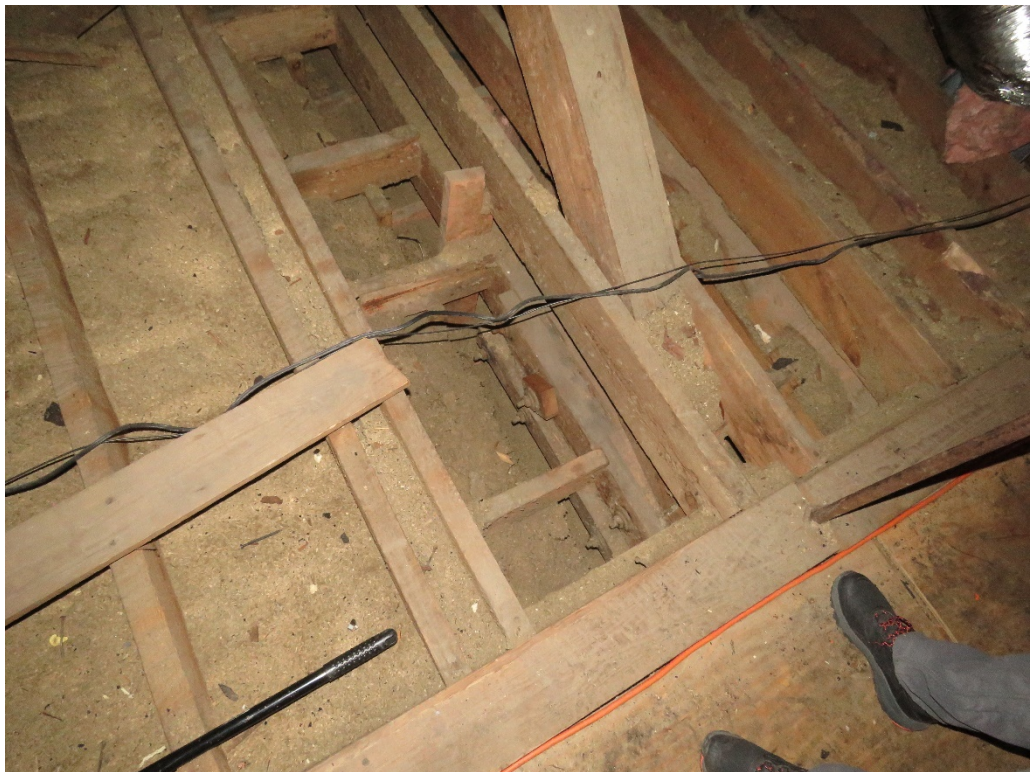
This truss cannot be simply classified. While it might appear to be a parallel to a Pratt or Howe truss, in reality it has wooden members intending to act in tension and other wooden members clearly acting in compression. The wooden tension members are, unfortunately, connected at their ends with compression-only connections, making these wooden tension members useless. Therefore, the truss ends up acting as a Howe truss with only the wooden compression members effective as shear carrying web members. To further complicate matters, the compression members are cut away where they cross the wooded tension members, forcing an eccentric compression load into the remaining half section. There are, however, tension rods at the approximate quarter points and at the center. Truss 4 has a tension king post threaded rod in the center of the truss approximately 1 inch in diameter. See Figures 18 and 19.

Figure 18: Quarter point rod on east side of Truss 4

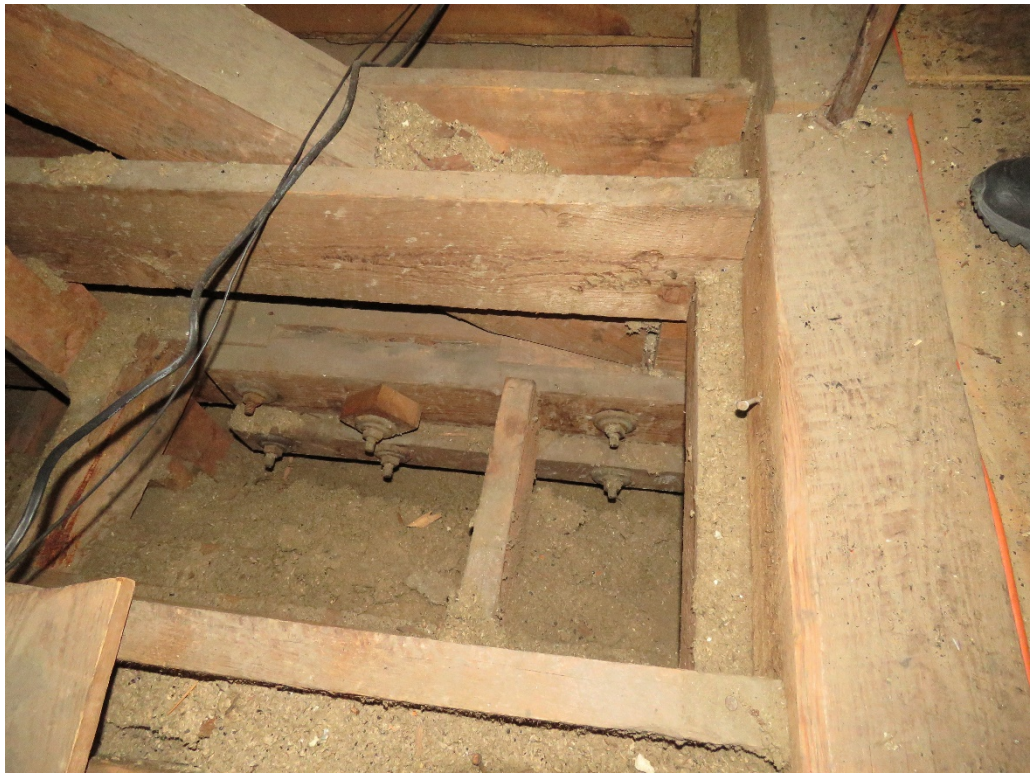
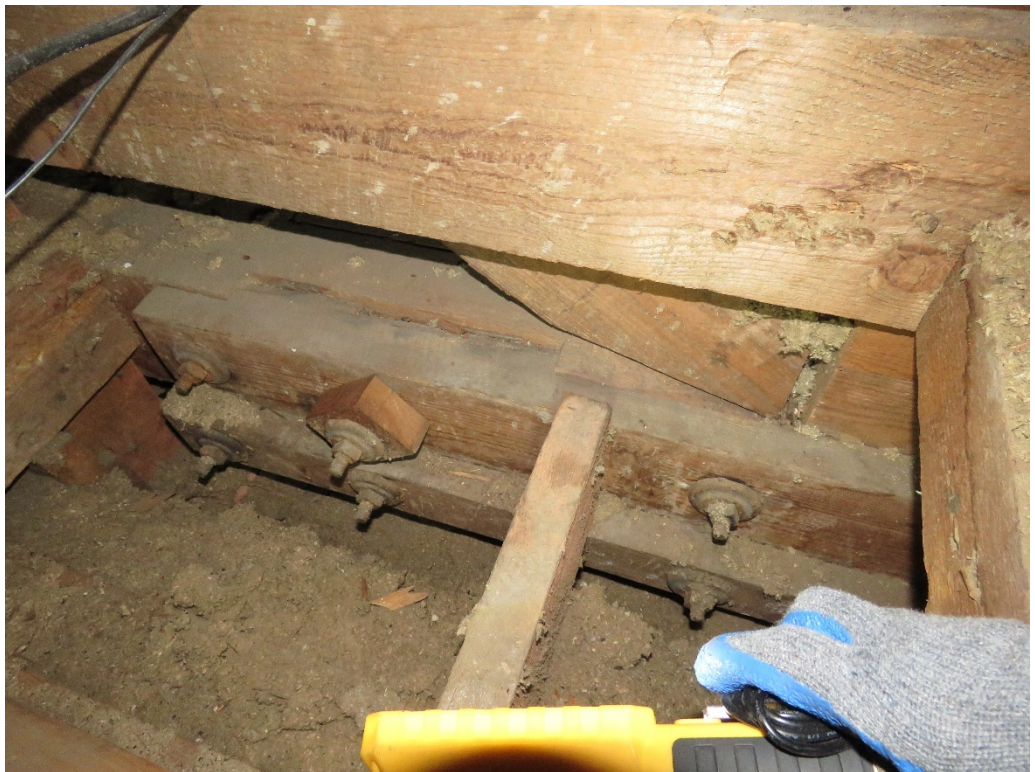
The bottom chord of the truss is made up of two 8x10 timber members, each half the length of the truss and joined in the middle, under the king post rod. The truss members are joined by a wooden side plate let into vertical dadoes cut into the sides of the bottom chords. See sketch in Figure 22. Bolts are used to hold the bottom chord and the wooden side pieces on the north and south faces of the chord together. See Figures 20 and 21.

Figure 20: Center rod and bolts at Truss 4 bottom chord

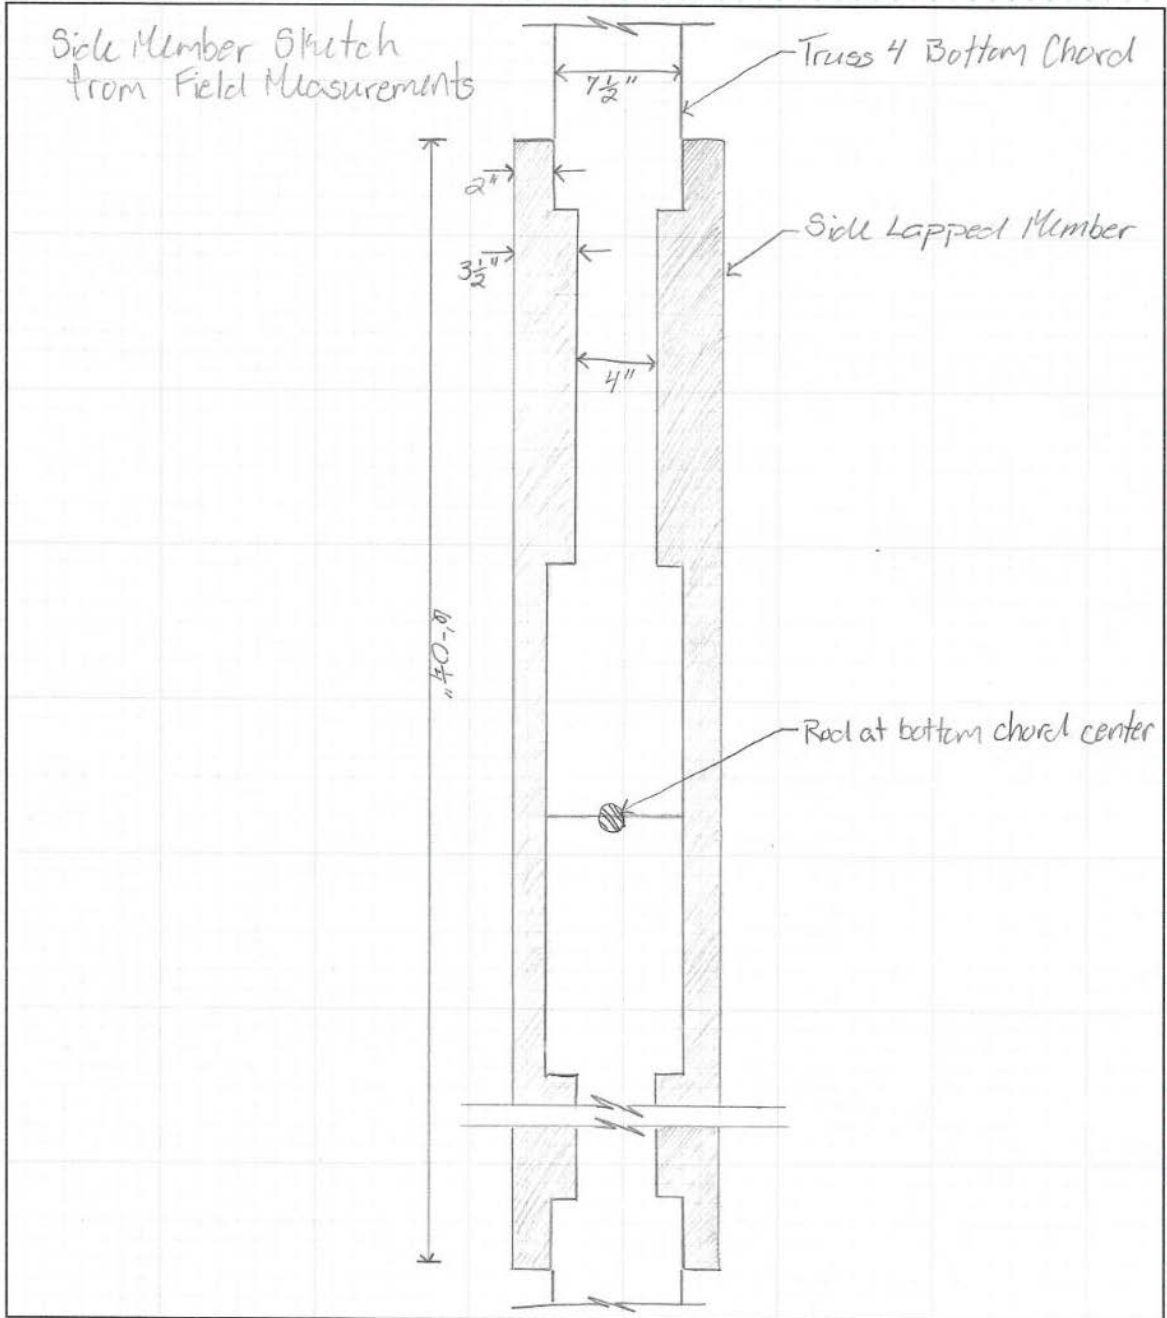
Figure 22: Plan view of wooden side pieces at Truss 4 bottom chord (bolts excluded)

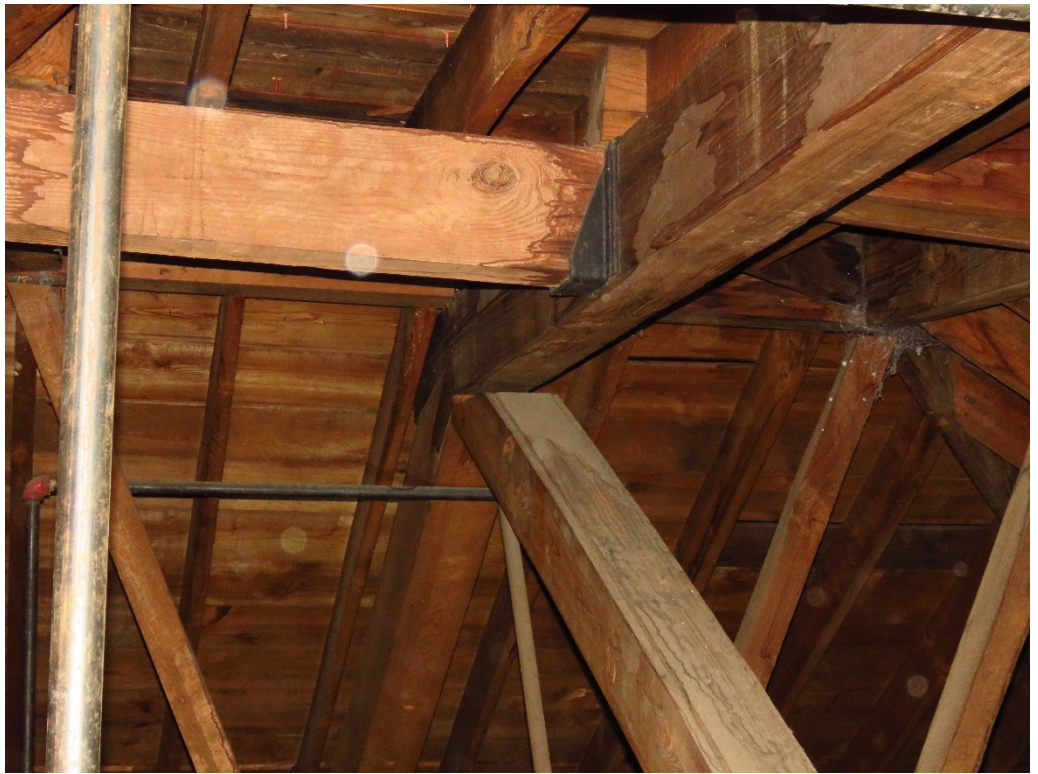
The diagonal member running from the center of the bottom chord outward to the top chord on each side of both the trusses was removed from both the Truss 1 and Truss 4 models. As seen in Figures 23 and 24, the diagonal member has detached from the top chord and is no longer receiving any load.

Figure 23: Disconnected diagonal at Truss 1

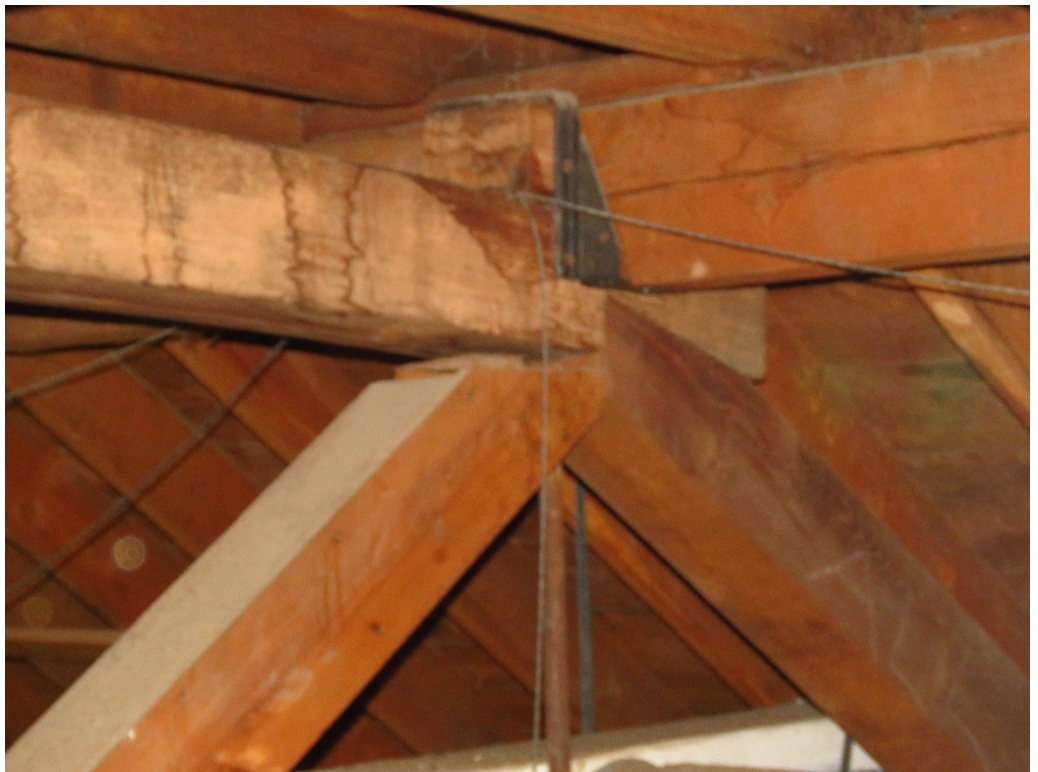
Figure 24: Disconnected diagonal at Truss 4
