RENOVATIONS FOR

YORK COUNTY SHERIFF'S FACILITY

ASBESTOS SURVEY

ECS PROJECT NO. 49:19708

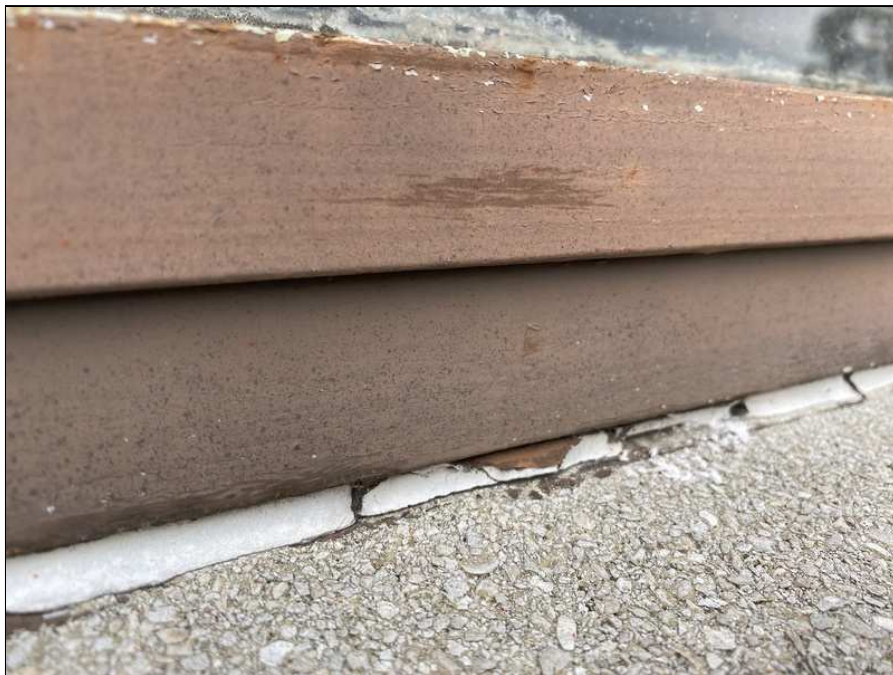
2 - Additional view of ACM window caulking.

ECS recommends that ACMs are properly abated prior to disturbance by renovation or demolition activities.

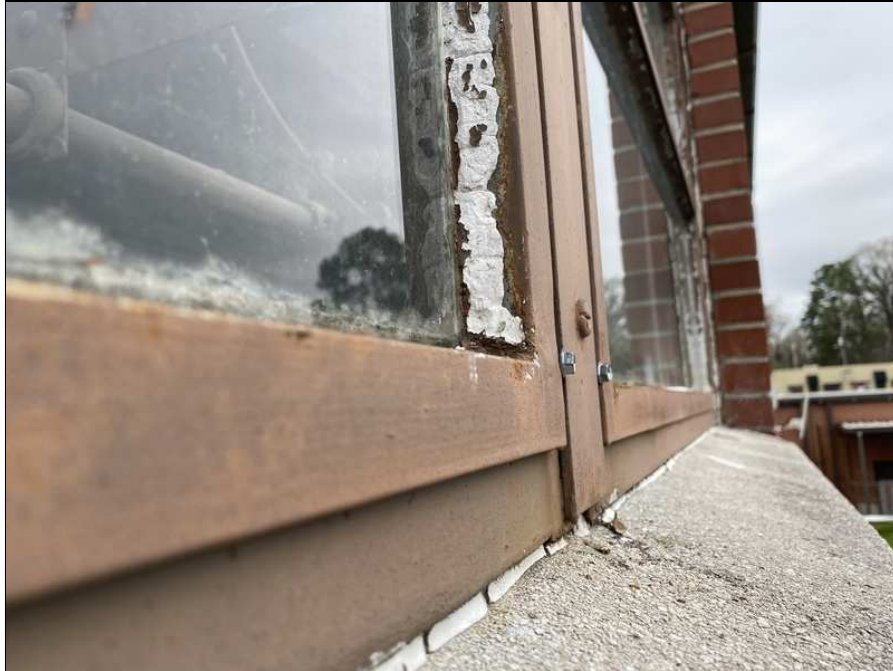
3 - View of ACM window glazing and caulking.

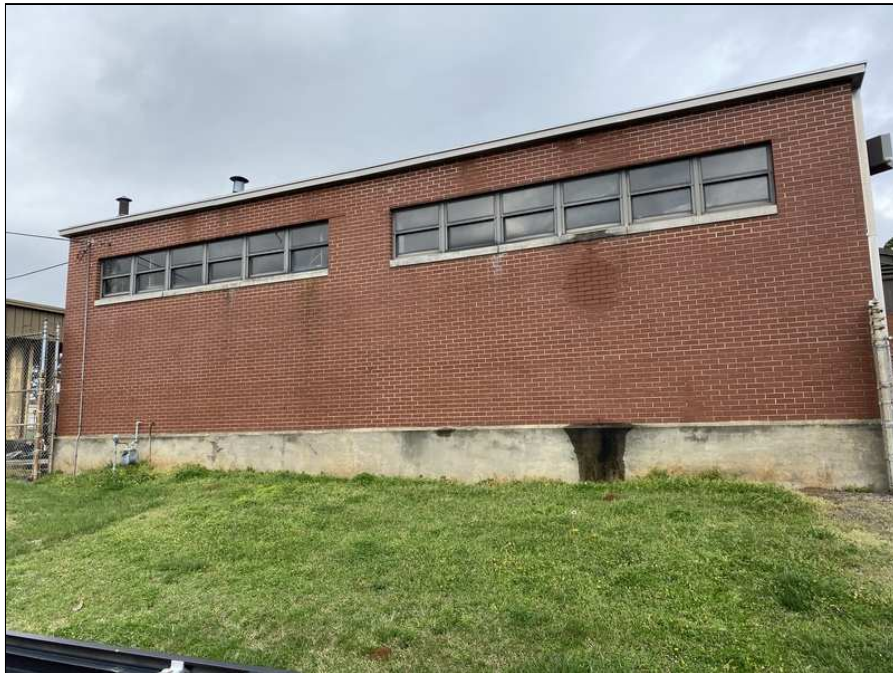
4 - View of the office building and non-ACM window caulking and rubber/silicone glazing.

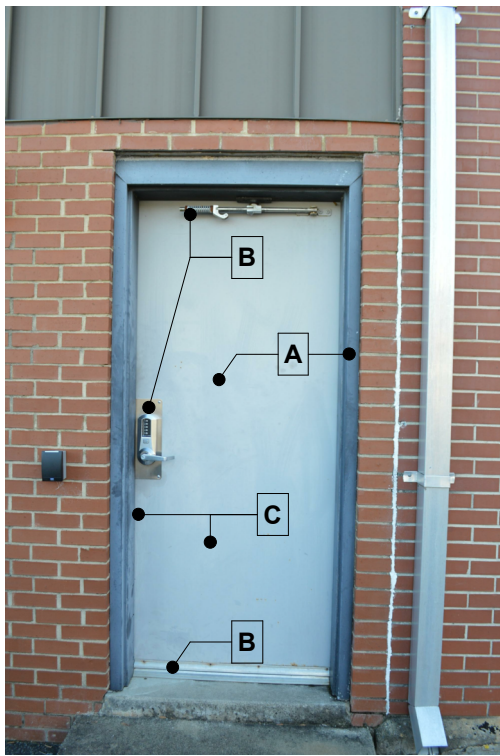
ENTRANCE DOOR TO SWAT BUILDING

- A. This door and frame appear to be in good condition.
- B. Remove bottom sweep and threshold and clean thoroughly. Remove all hardware and clean and prepare for re-use. Clean concrete surface below threshold and prepare for patching and leveling. Patch and level concrete with " Abocrete " Epoxy Patching and Resurfacing Compound.

- C. Remove all paint and rust from door and frame. Remove all caulking from joints on both front and back.
- D. Where rust has damaged frame, clean, sand or grind out and repair with " ABATRON " Ferrobond-P Steel-filled structural adhesive putty.

- G. Caulk(use Sikaflex-1A) around door frame to brick joint with polyurethane sealant in gray color.
- H. Re-install all hardware after cleaning. Use only stainless steel screws. Bed threshold in a full bed of polyurethane mastic.

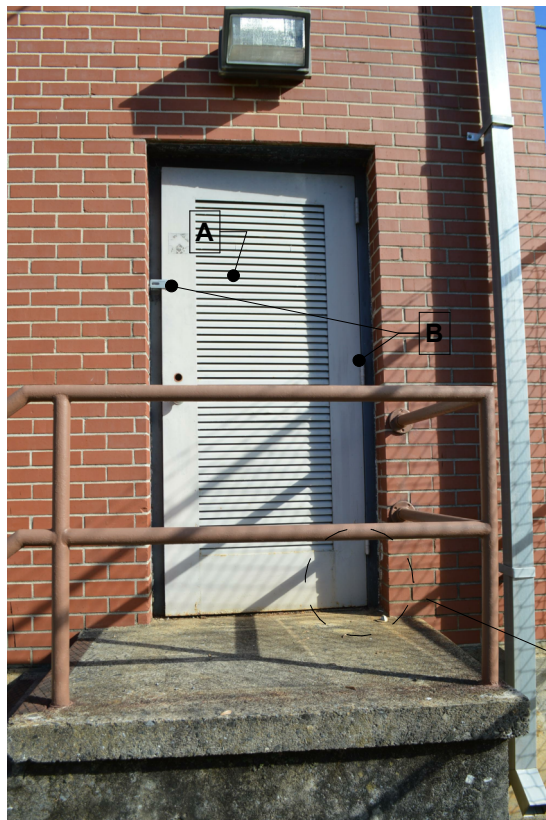
SWAT BUILDING OUTSIDE STORAGE ENTRANCE DOOR

- A. Remove and Replace louvered door only. Frame appears to be in good condition. The following work is required.
- B. Remove all hardware. Clean concrete surface below existing door and prepare for patching. Patch concrete with "Abocrete" Epoxy Patching and Resurfacing Compound.

- C. Remove all paint and rust from frame. Remove all caulking from joints on both front and back. Where rust has damaged frame, clean, sand or grind out and repair with "ABATRON" Ferrobond-P Steel-filled structural adhesive putty. Sand and prep frame for primer and painting.

- E. Caulk (use Sikaflex-1A) around door frame to brick joint with polyurethane sealant in gray color.
- F. Install new hardware after cleaning. Use only stainless steel screws.

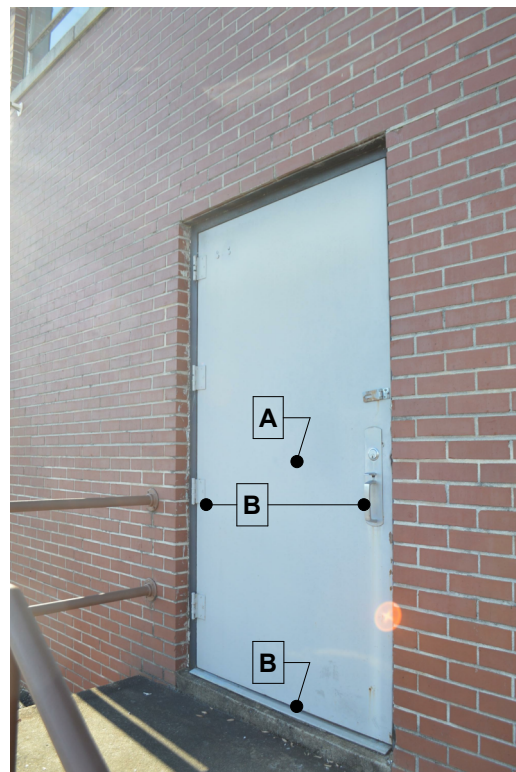
EVIDENCE BUILDING ENTRANCE DOOR

- A. This door and frame appear to be in good condition.
- B. Remove bottom sweep and threshold and clean thoroughly. Remove all hardware and clean and prepare for re-use. Clean concrete surface below threshold and prepare for patching and leveling. Patch and level concrete with "Abocrete" Epoxy Patching and Resurfacing Compound.

- C. Remove all paint and rust from door and frame. Remove all caulking from joints on both front and back.
- D. Where rust has damaged frame, clean, sand or grind out and repair with "ABATRON" Ferrobond-P Steel-filled structural adhesive putty.

- G. Caulk (use Sikaflex-1A) around door frame to brick joint with polyurethane sealant in gray color.
- H. Re-install all hardware after cleaning. Use only stainless steel screws. Bed threshold in a full bed of polyurethane mastic.
