A Report on Structural Roof Framing at The McCelvey Center

York, South Carolina

Submitted to:
Culture & Heritage Museums

Thursday, May 12, 2022

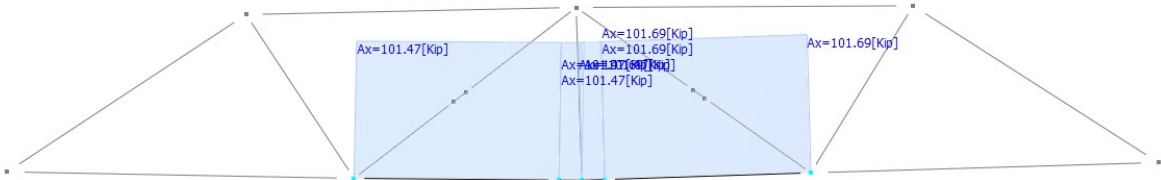
Truss 1 Axial

For Truss 1, the truss over the stage that has already failed, early couple analysis showed that the truss bottom chord carries an approximately 38 kip tension load under dead load alone and an approximately 72 kip tension load under a dead plus live load. If the dimensions of the middle cross section at the break are taken as 4 1/4 inches by 6 inch and the areas above and below the bolts are taken as 7 1/2 inches by 5/8 of an inch, the remaining cross-sectional area of the truss is approximately 34.9 or 35 square inches. Based on these figures, the dead load tension stress would be approximately 1070 psi. The dead plus live load tension stress would be approximately 2050 psi.

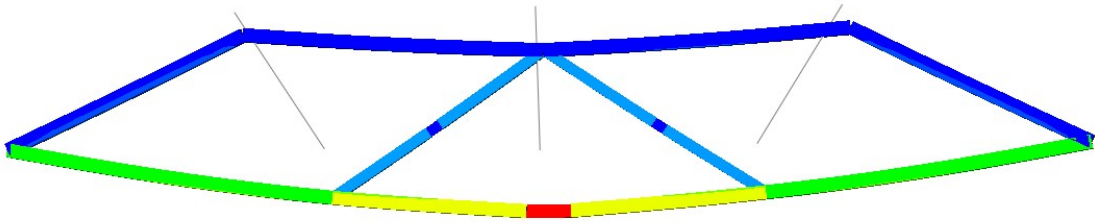
Truss 1 Stresses

375 for No. 2. Under all likely assumptions about the species and grade of wood, the applied stress under dead load plus live load grossly exceeds the allowable stress. Even under dead load alone, depending upon the species and grade of wood, the applied stress could be significantly greater than the allowable. The surprising thing is not that the truss failed but that it did not fail sooner.

Under all conditions of loading and analysis, and all assumptions about species and grading of wood, both Truss 1 and Truss 4 are grossly and unacceptably overstressed.

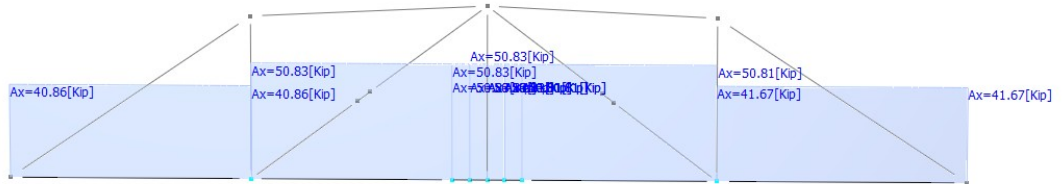
Truss 4 Axial

Truss 4 in the attic, the second truss south of the north wall, is observed as a typical condition of the five trusses over the auditorium (all trusses besides Truss 1 over the stage).
